## 230 point Porsche Report

Order No.:

5522

Date of inspection	19.07.2019
Model, type	3.2 Targa
Car registration number	A724 AMK
Colour	Grand Prix White
Recorded mileage	66468 (speedo change in 1989, apx 143k total)

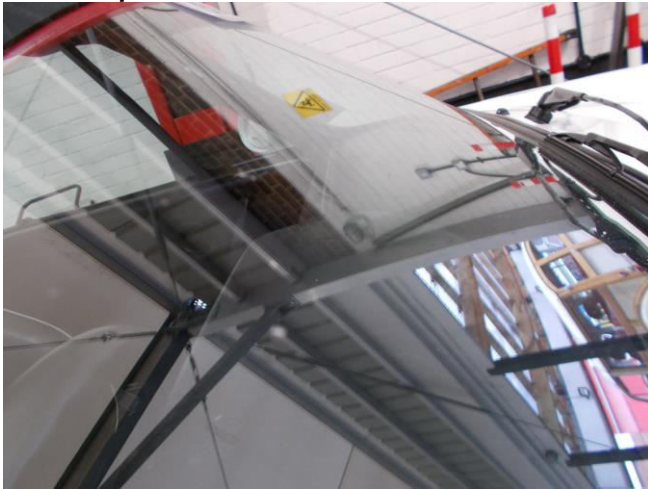
**Small chips in screen**

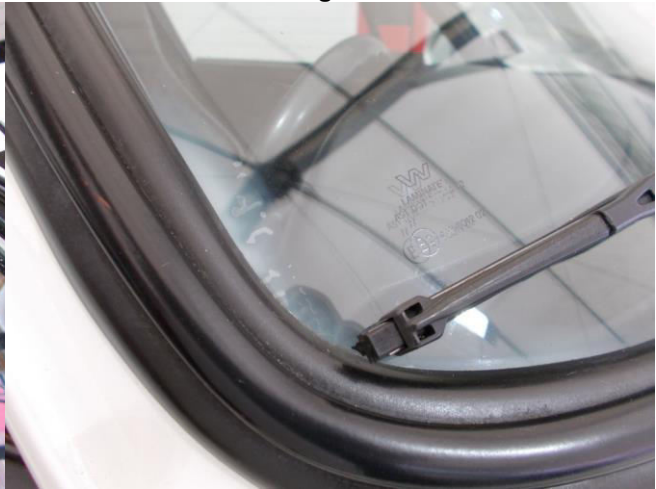
**some delamination at edge**

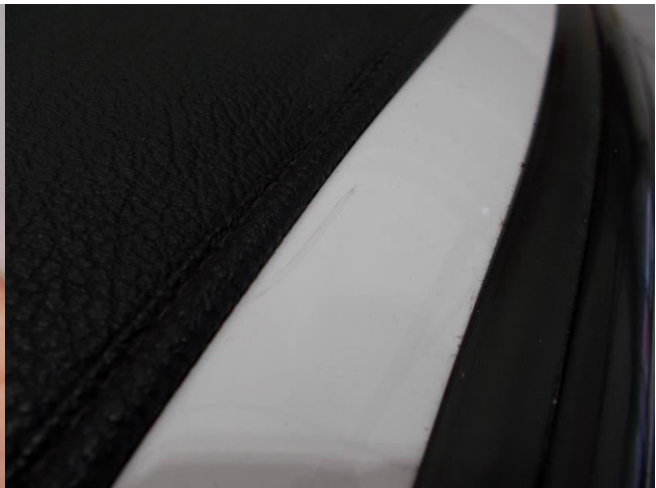
**Small blemish base of OS door**

**scratch on roof**

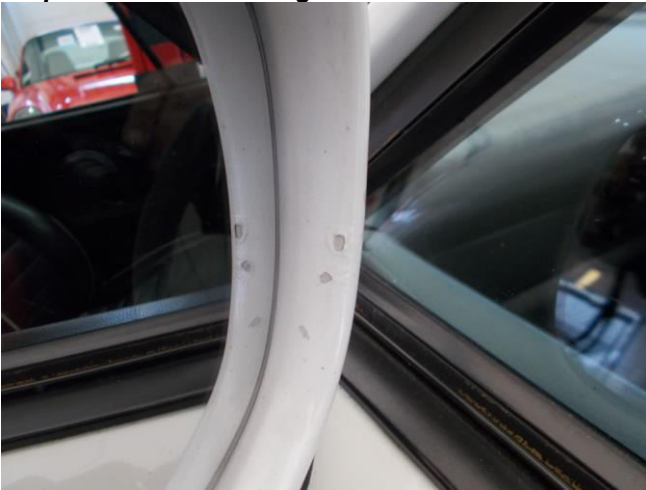
***Chips on mirror housing***

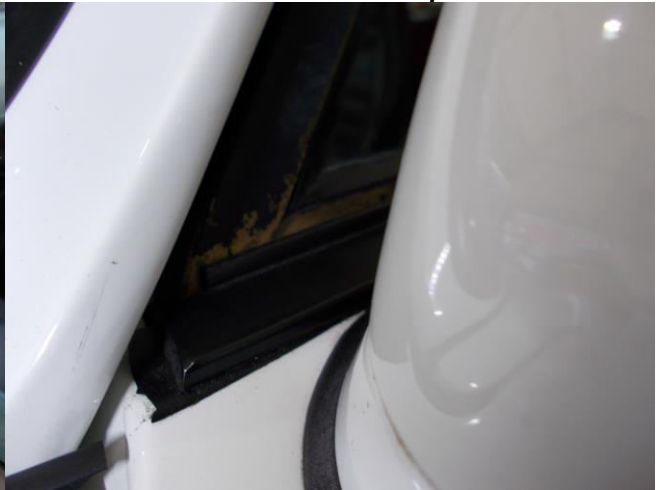
***worn finish on window frames in places***

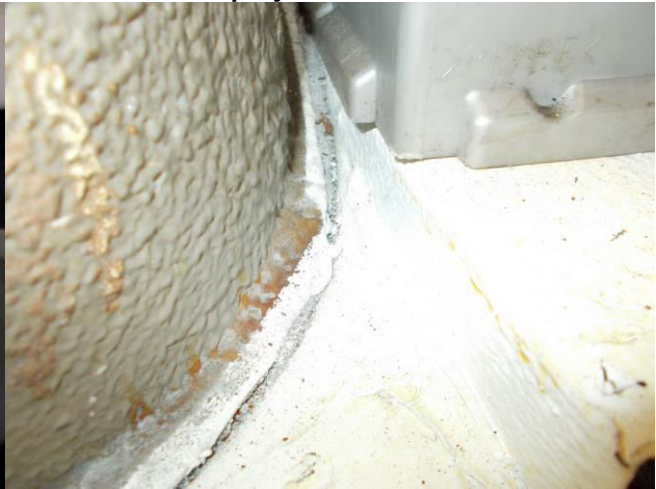
***some small overspray***

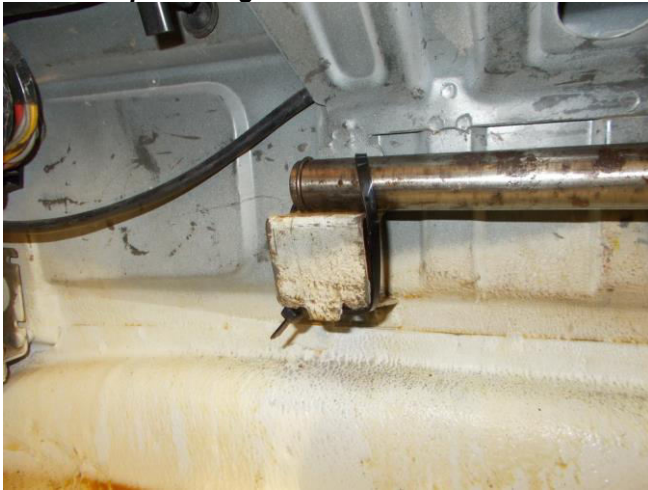
**Jack clamp missing**

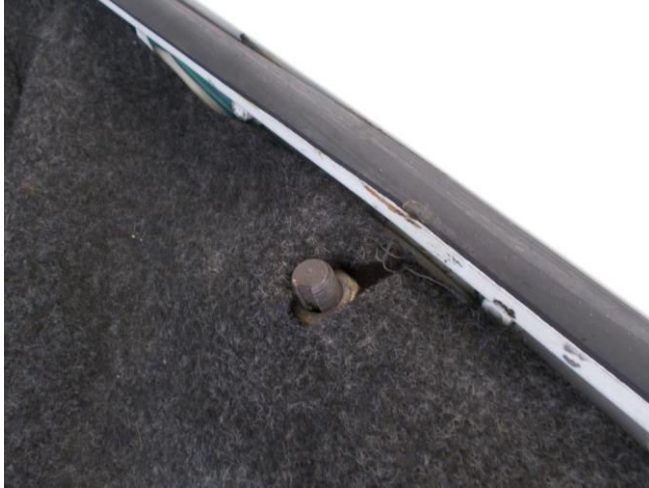
**Some wear to boot carpet**

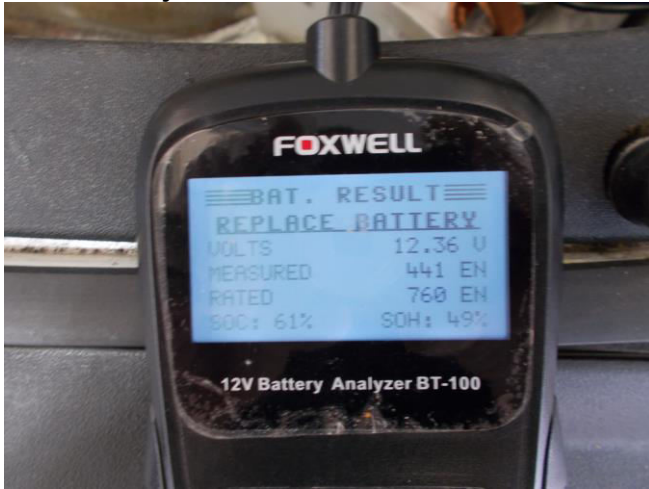
The interior is well preserved and is clean and tidy throughout. The floor is dry and there are no signs of dampness (unusual for a Targa). The seats and door panels show a level of wear in line with the age and mileage. Some of the carpets are torn and one of the rear seatbelts is missing. A few electrical items are not working - the headlamp washers, a few bulbs and the electric mirrors – the mirrors are later items and may not be compatible. The battery failed a test and needs to be replaced.

**Failed battery test**

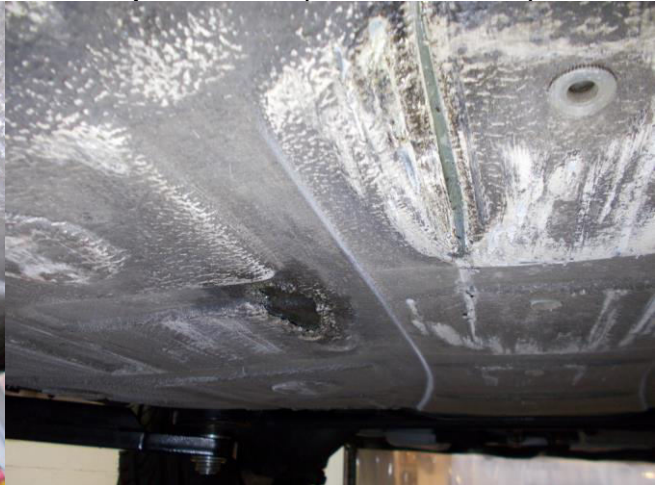
**some scrapes to floors (have been waxed)**

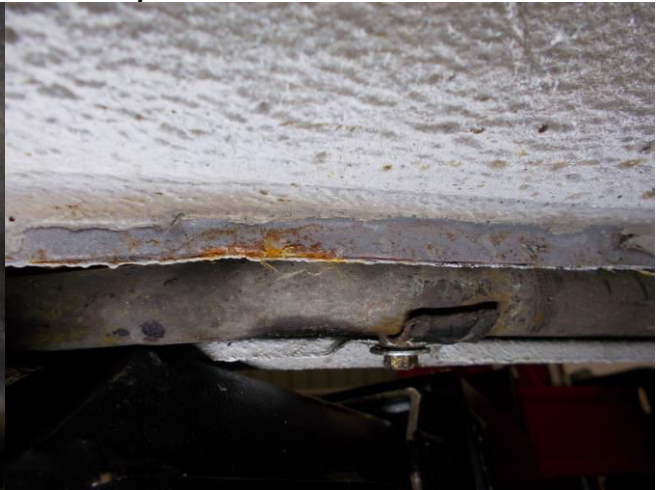
**underseal peeled on OS sill**

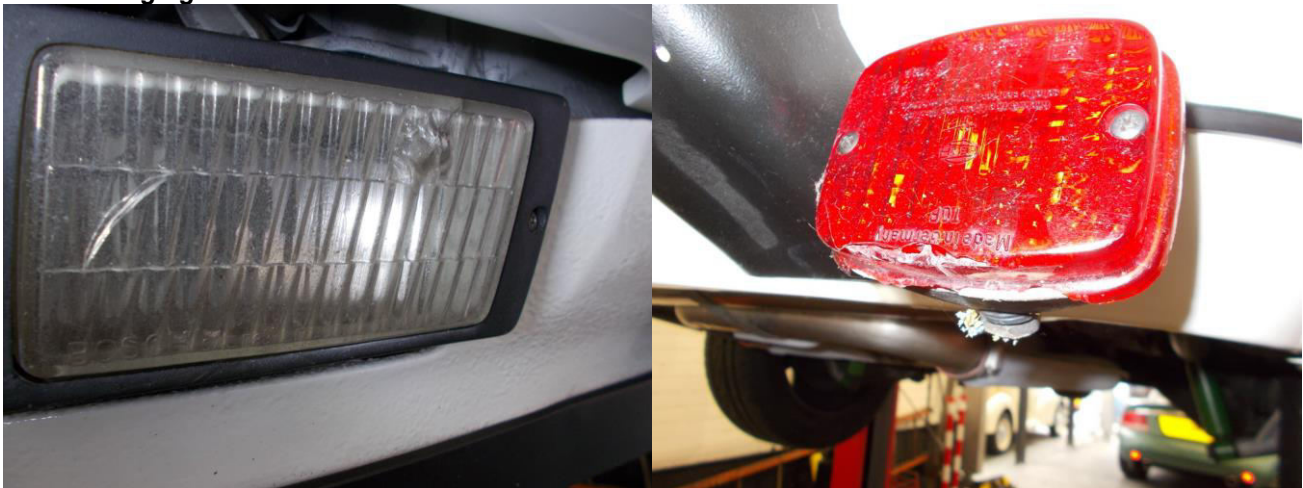
**Cracked fog lights**

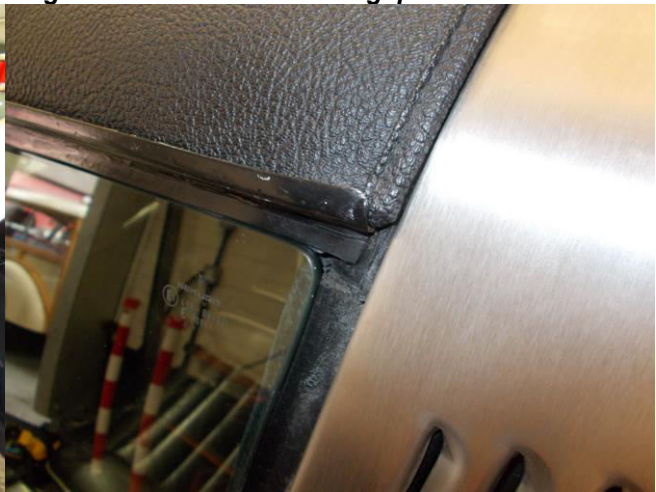
The car performed well on test drive with no rattles or knocks from suspension or interior. Although congestion limited the speeds, the engine pulled well and showed good oil pressure, there was no smoking from the exhaust. The gearbox was ok, the 915 has a reputation for being a little difficult and this one was no different, with a slightly vague action. The Targa roof proved to be leaking above both doors (particularly the drivers side).

**Targa roof side seals have a gap**

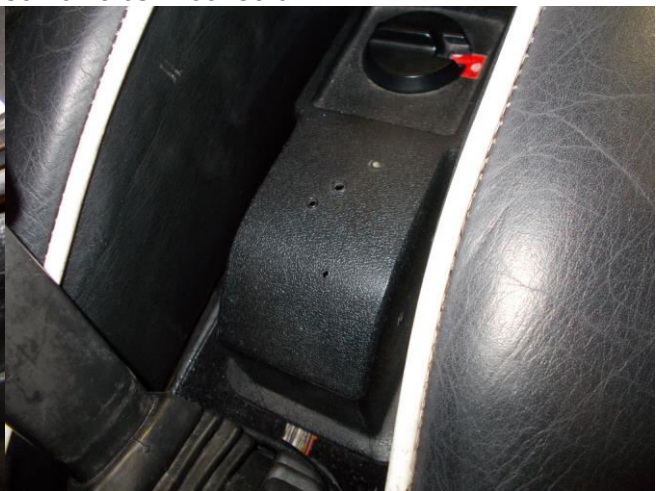
**some holes in console**

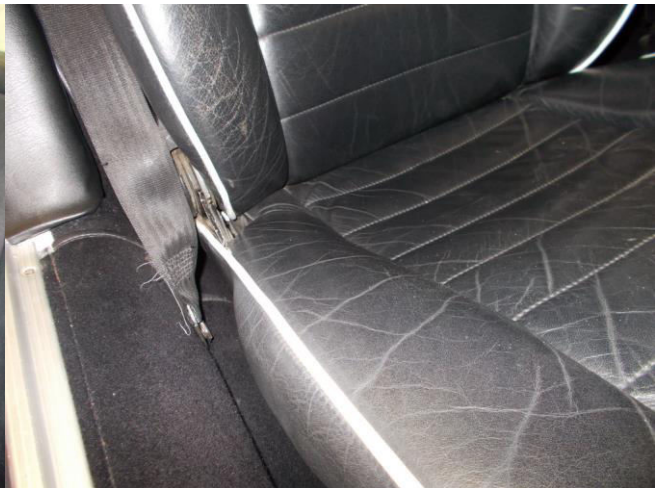
**some wear to driver seat**

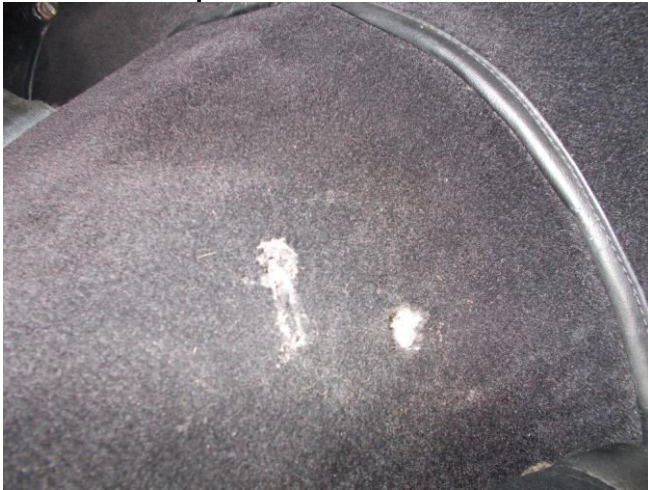
**Hole in rear carpet**

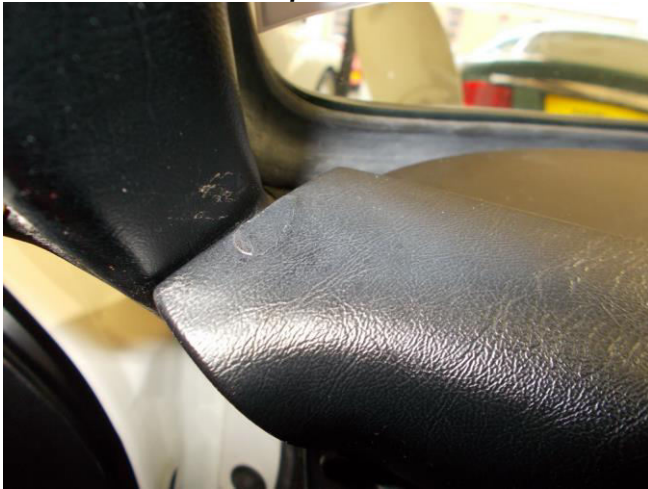
**Glue marks on dash top**

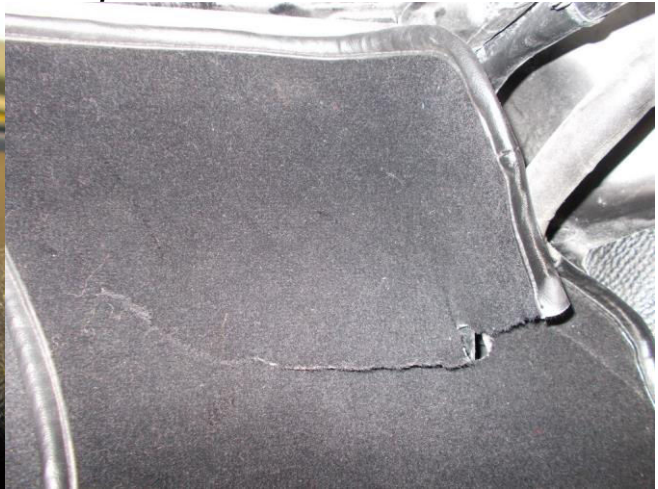
**torn carpet NS footwell**

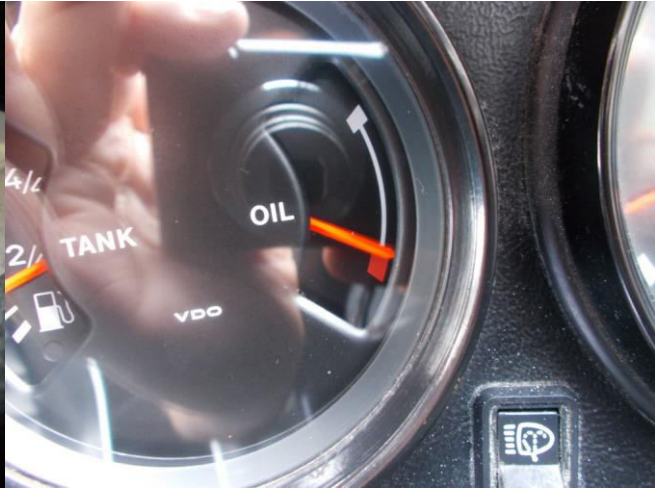
**oil level at minimum**

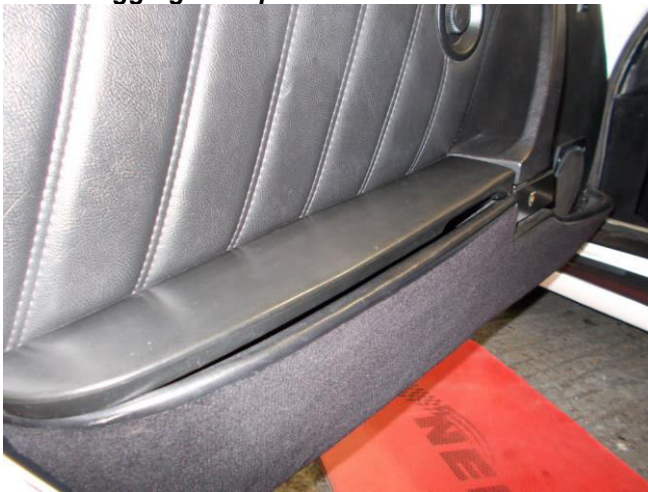
**Usual sagging door pockets**

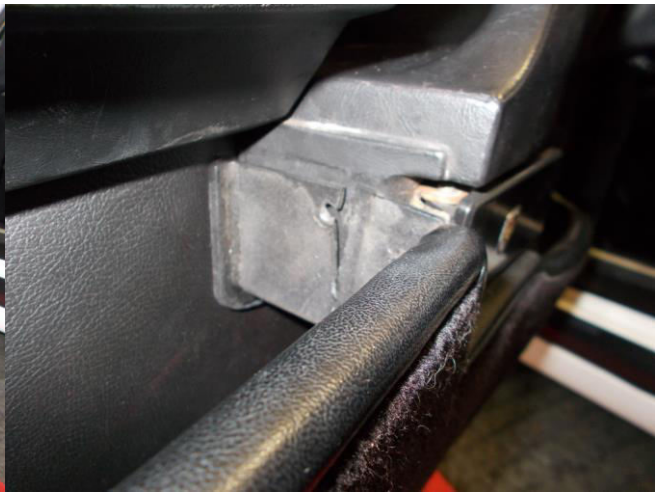
**cracks inside**

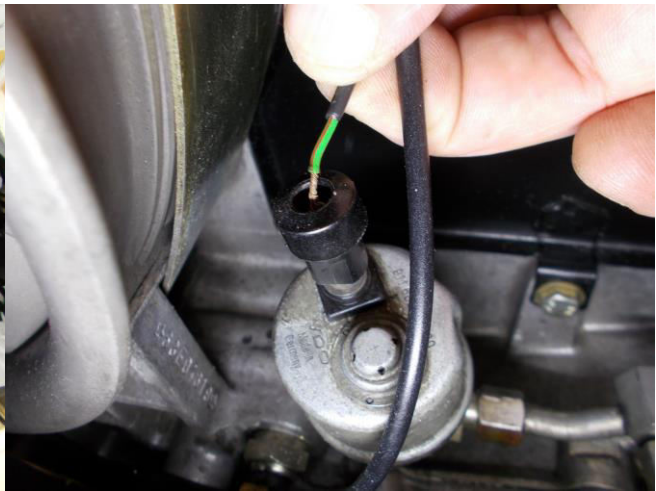
**loose wire on oil sender**

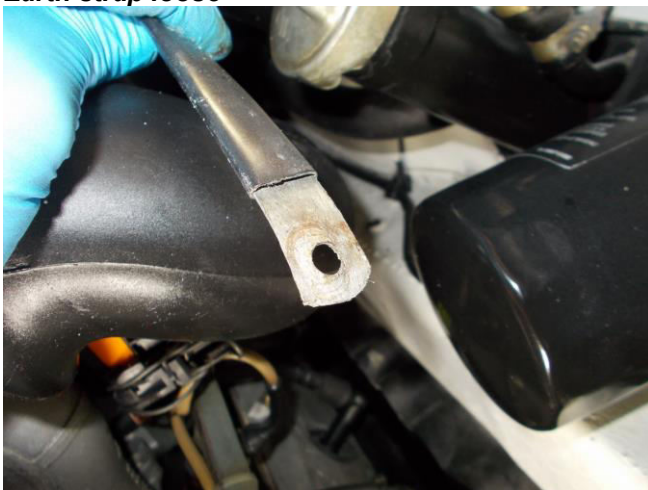
**Earth strap loose**

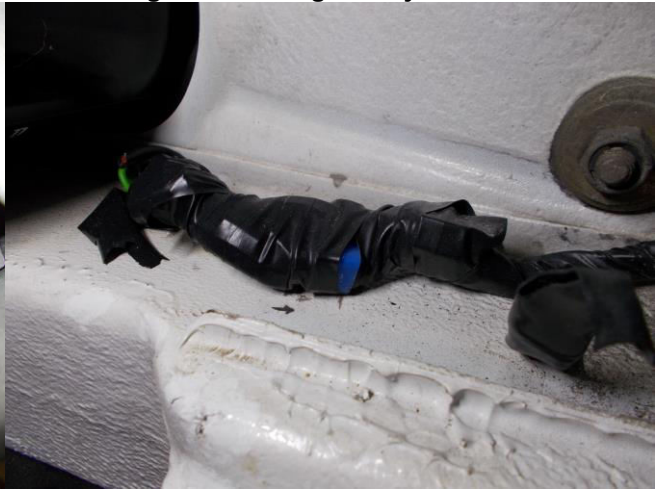
**some wiring mods in engine bay**

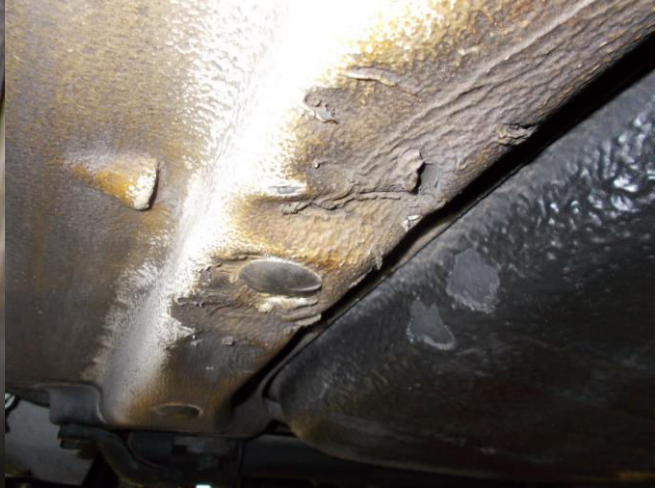
**jacking dents at front**

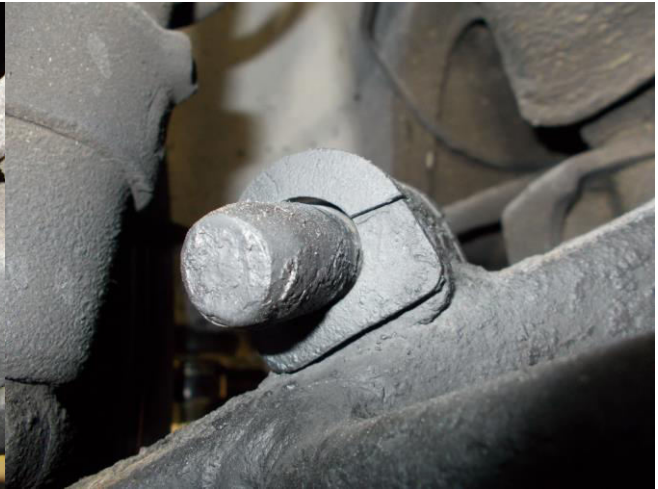
The suspension is good, there is a little wear showing on some of the roll bar bushes. Dampers are leak free.

**minor wear to front roll bar bushes**
