Vehicle History Report

Chassis number ¹: RP3-1007445

Make: HONDA

Model: STEPWGN

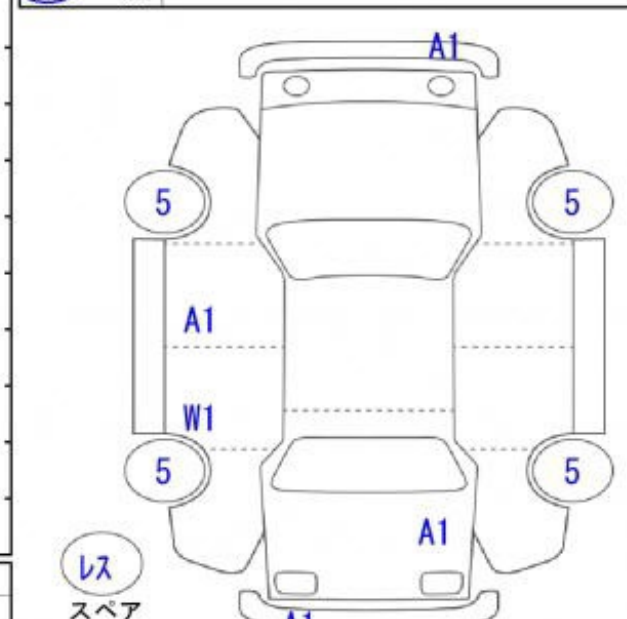
外装 小A・小U	
ボディー部同色塗装有り	
Rワイパー欠	
エアロ下部スリA	
室内汚れ小、ダッシュのり跡	
天張り加工、内張り加工ねじ穴	
社外サス、車高低い	
ガラスフィルム貼り付け

フロントガラス	キズ・ 飛石 ・ヒビ割・リペア跡・X要
内装	キズ・汚レ・コゲ・穴・スレ・キレ・破レ
