Vehicle History Report

Chassis number ¹: MR41S-638564

Make: SUZUKI

Model: HUSTLER

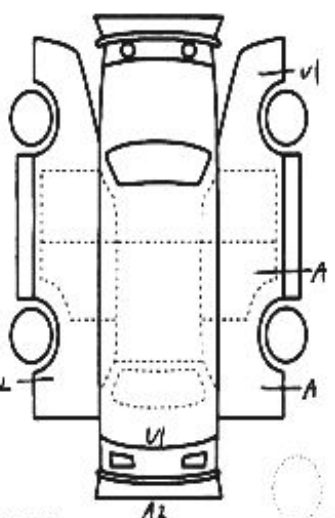
Q検査員報告 (USS使用)

ル-ム内 汚染、新物

人ミラー 不

小キズ 小凹

ボイル 不
