Vehicle History Report

Chassis number ¹: MR31S-804292

Make: SUZUKI

Model: HUSTLER

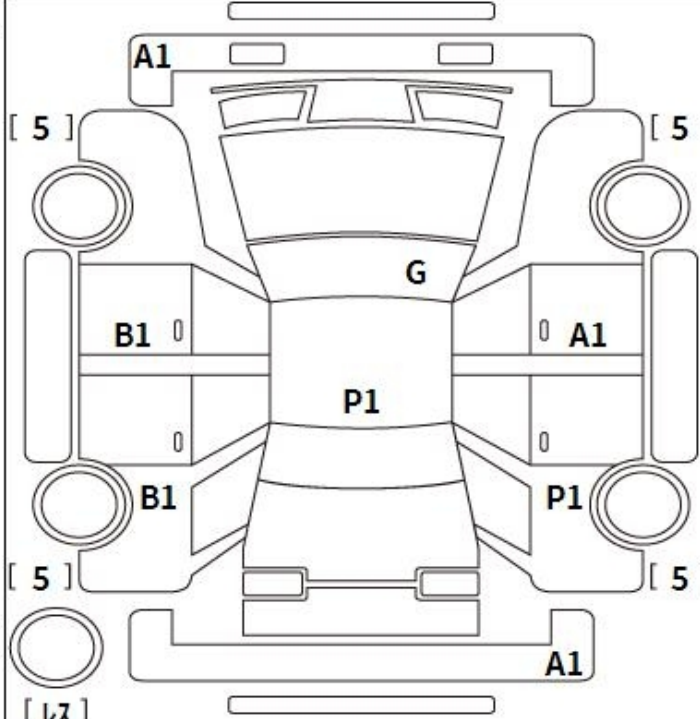
検 査 員 記 入 欄	
外装のり跡 室内内張傷
