Vehicle History Report

Chassis number [1]:	MR31S-846897
Manufacture date:	2015-09-25
Make:	SUZUKI
Model:	HUSTLER
Body:	DBA-MR31S
Grade:	G TURBO
Engine:	R06A
Drive:	2WD
Transmission:	AT

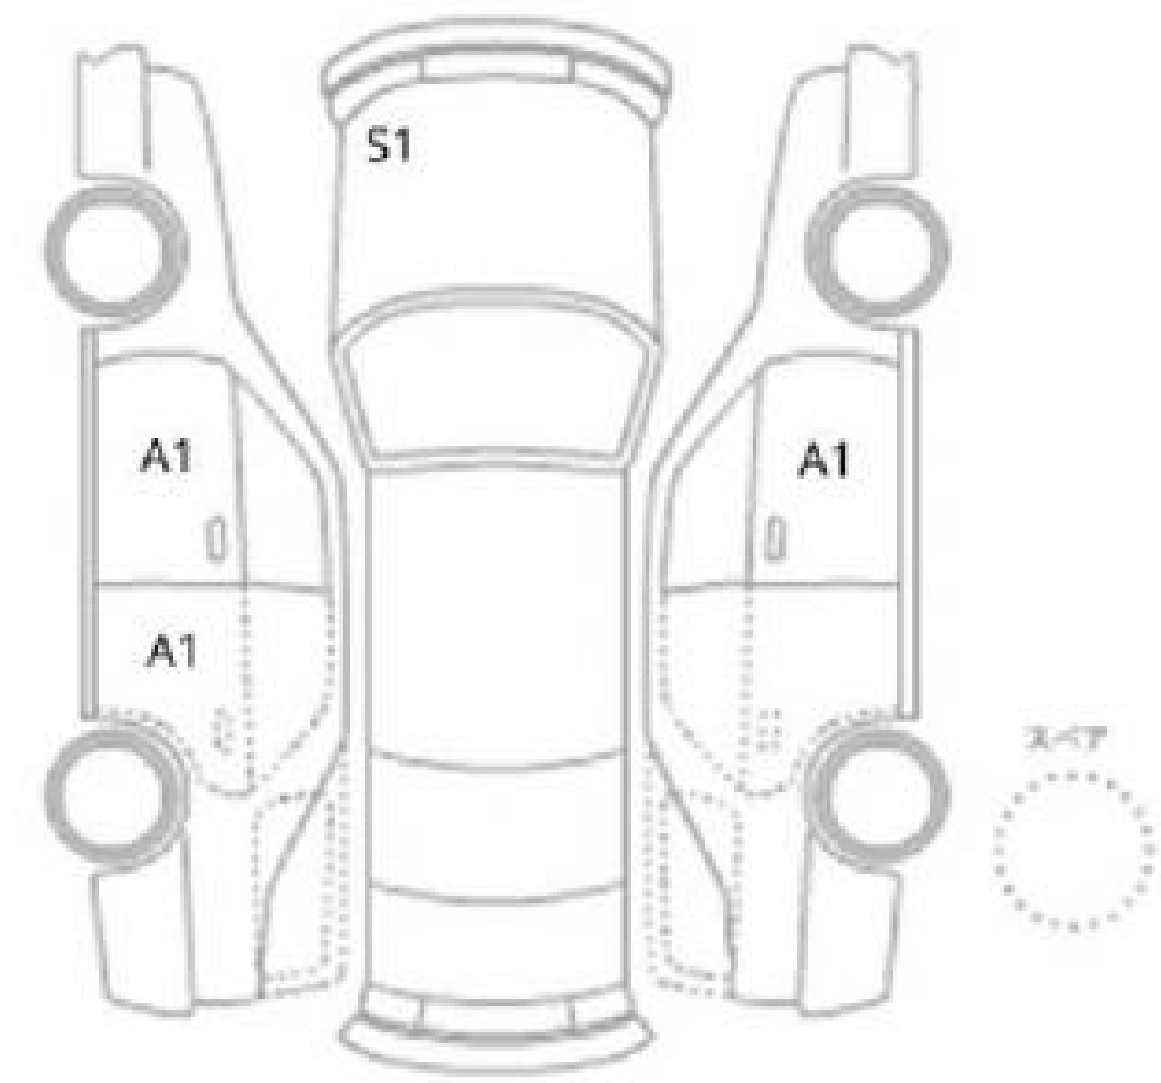
小キズ小凹み

FW				外装	小	ホイル	エアロ
	(トビ右)	(傷有)	ワレ		(A)・(U)	(A)・曲	A・ワレ

内装							
	(ヨゴレ)	シミ	ヤブレ	コゲ	コゲ穴	オーディオ穴	(スレ)

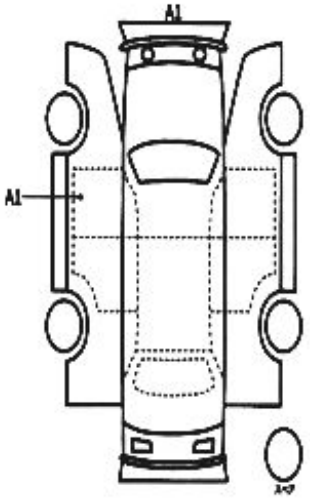
シートフチヘタリ

ルーム内うす汚れキズ

Dミラー色あせ

小キズ小凹
