## 230 point Porsche Report

Order No.:

5522

Date of inspection	19.07.2019
Model, type	3.2 Targa
Car registration number	A724 AMK
Colour	Grand Prix White
Recorded mileage	66468 (speedo change in 1989, apx 143k total)

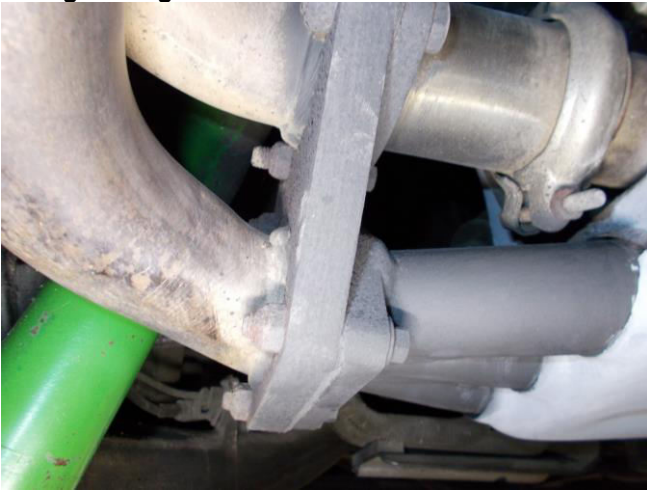
Fixing bolts good
