Vehicle History Report

Chassis number ¹: RP3-1007445

Make: HONDA

Model: STEPWGN

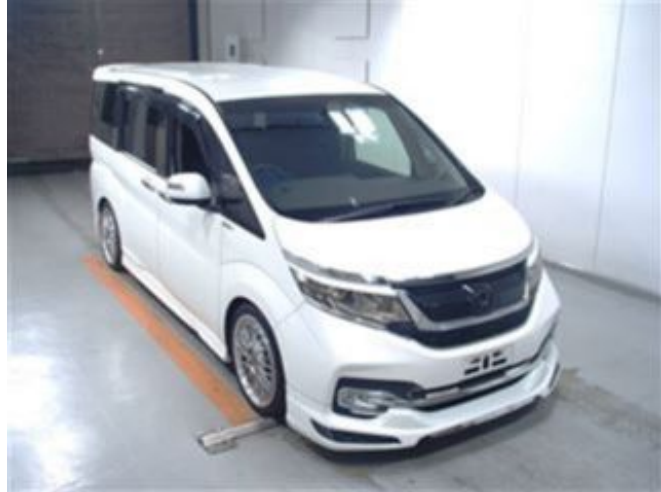
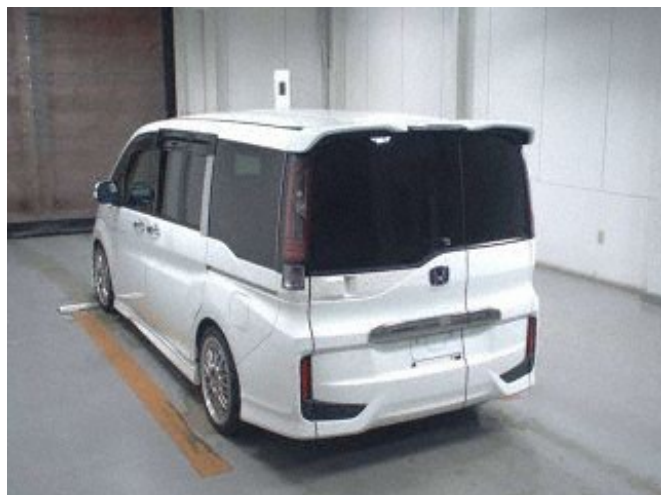
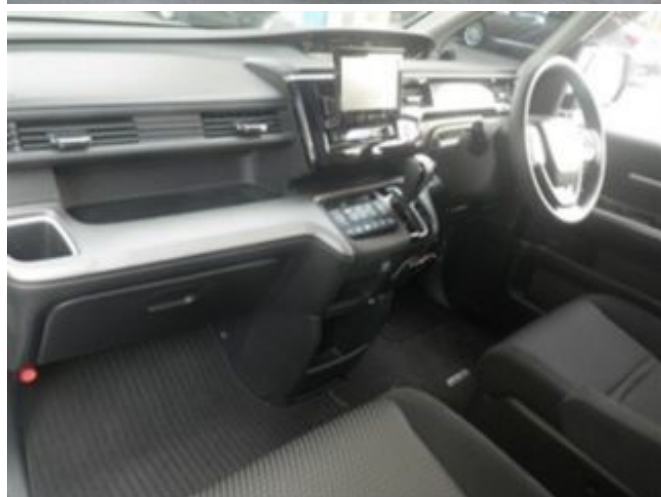
外装 小A・小U	
ボディー部同色塗装有り	
Rワイパー欠	
エアロ下部スリA	
室内汚れ小、ダッシュのり跡	
天張り加工、内張り加工ねじ穴	
社外サス、車高低い	
ガラスフィルム貼り付け

フロントガラス	キズ・ 飛石 ・ヒビ割・リペア跡・X要
内装	キズ・汚レ・コゲ・穴・スレ・キレ・破レ
