## 230 point Porsche Report

Order No.:

5522

Date of inspection	19.07.2019
Model, type	3.2 Targa
Car registration number	A724 AMK
Colour	Grand Prix White
Recorded mileage	66468 (speedo change in 1989, apx 143k total)

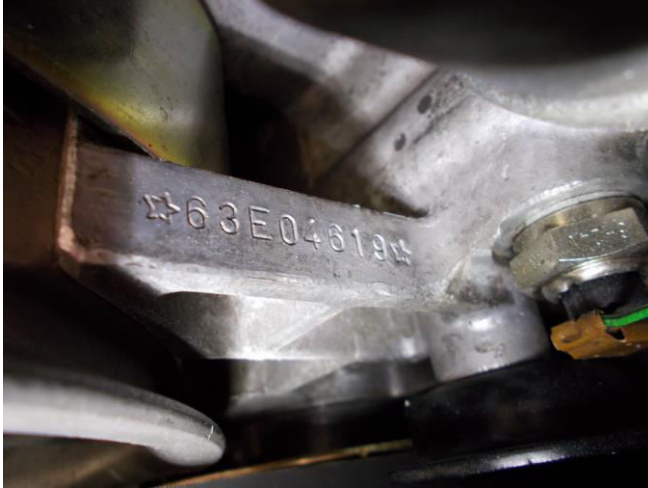
**Engine number 63E04619**

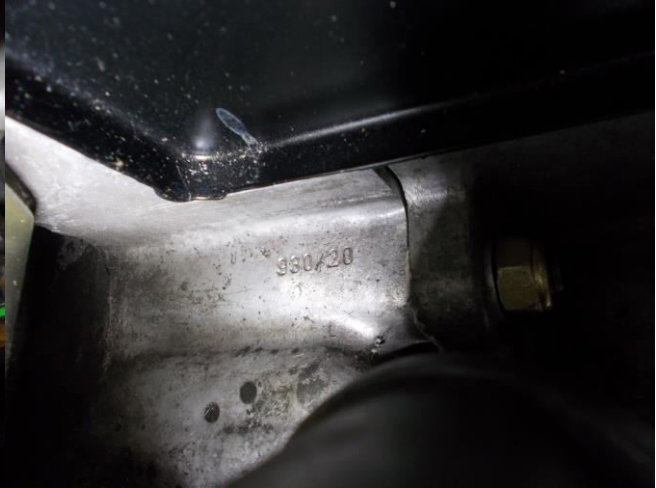
**engine type 930/20**

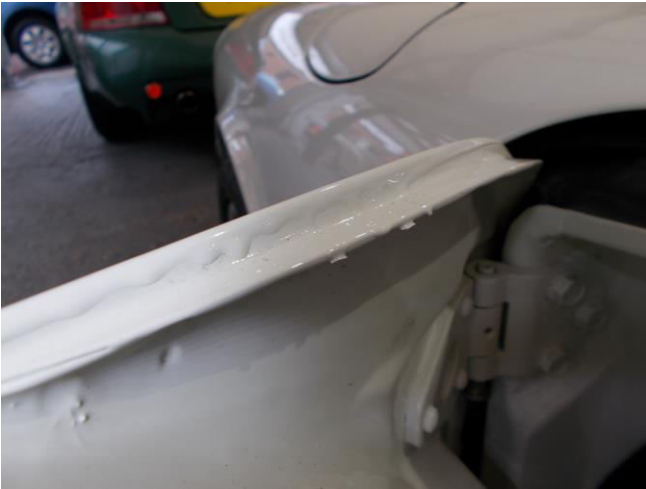
***some small overspray***

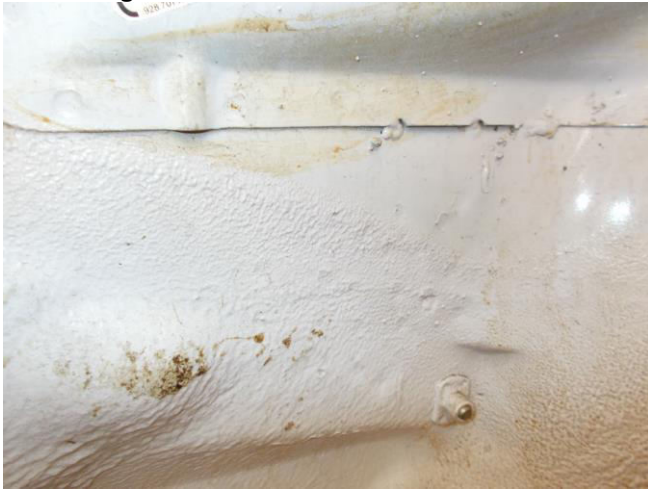
**no damage to front structure (orange colour is wax)**

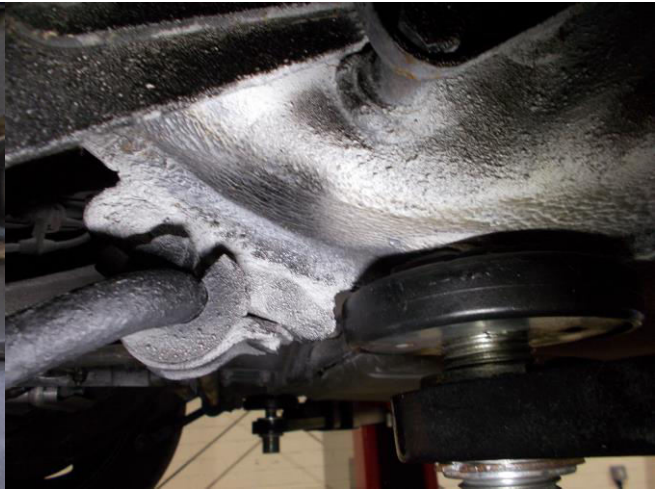
**Rear floor very good /original**

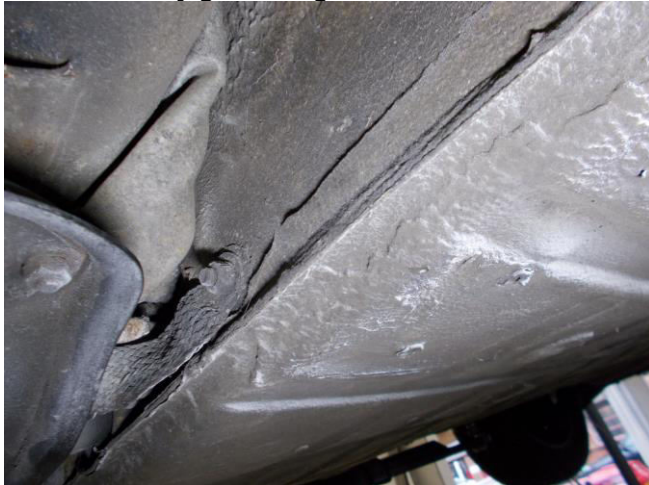
**some scrapes to floors (have been waxed)**

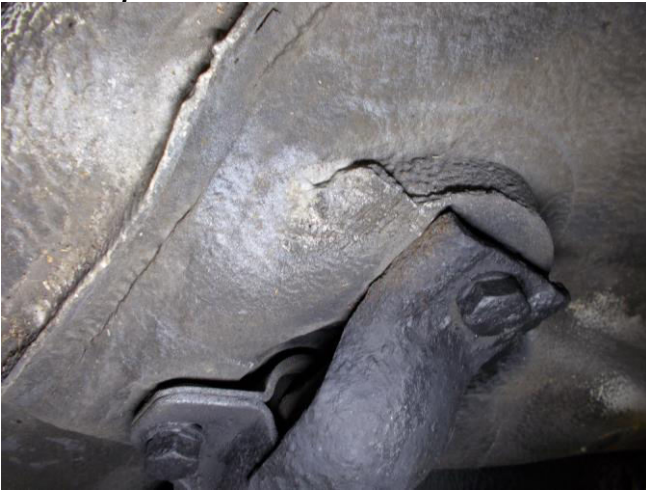
**underseal peeled on OS sill**

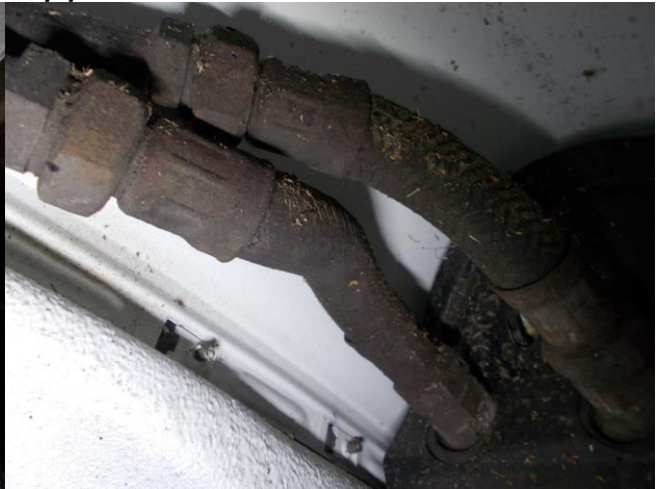
**OS kidney bowl area good / solid**

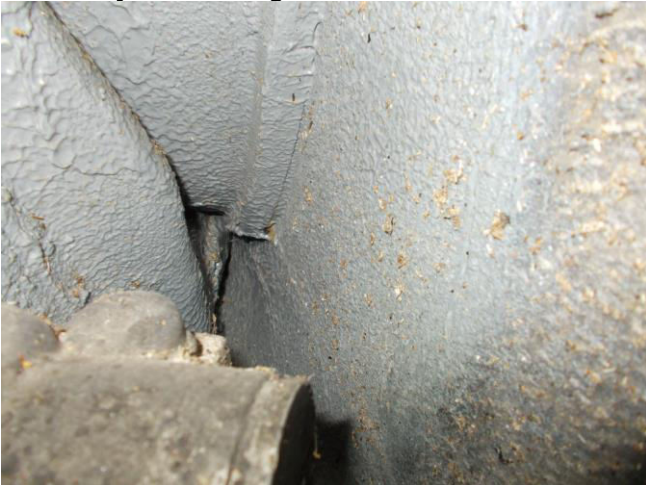
**rear bumper supports good**

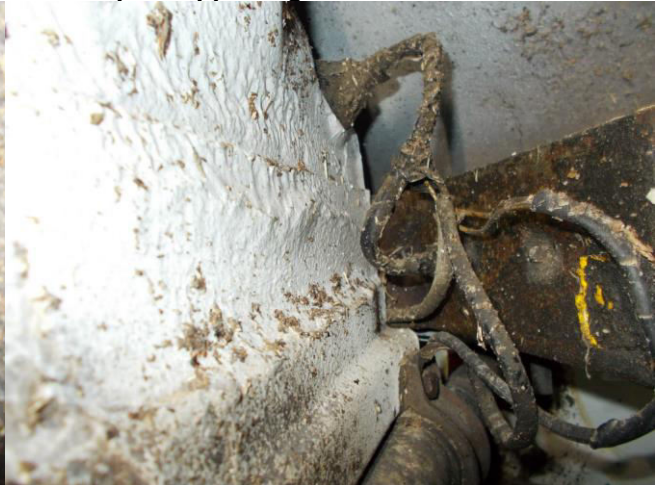
**NS B post and kidney bowl solid, well repaired**

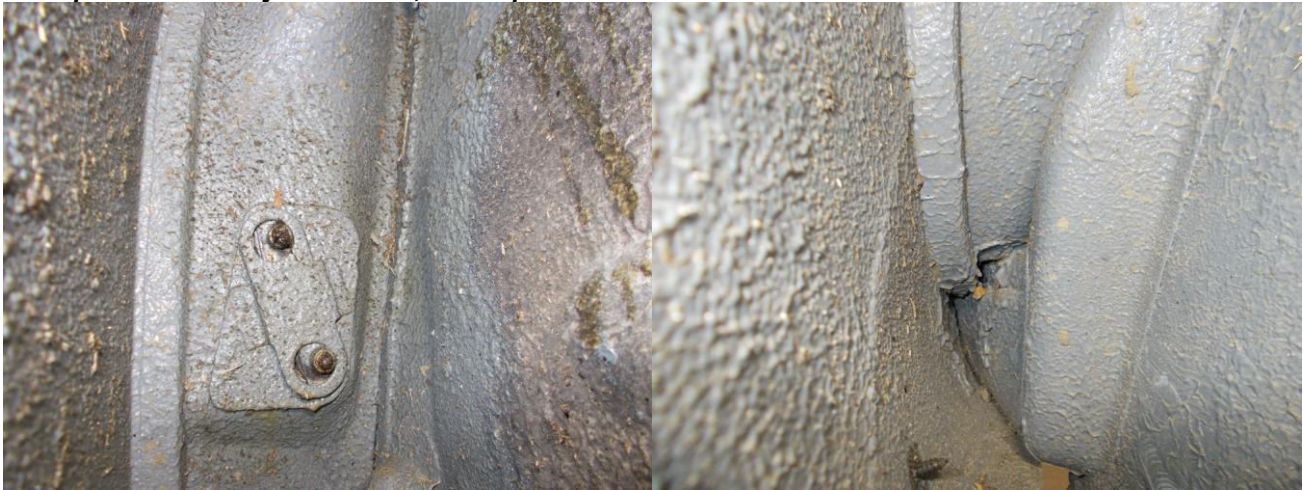
**OSF inner wing repainted**

**NSF inner wing not painted but solid**

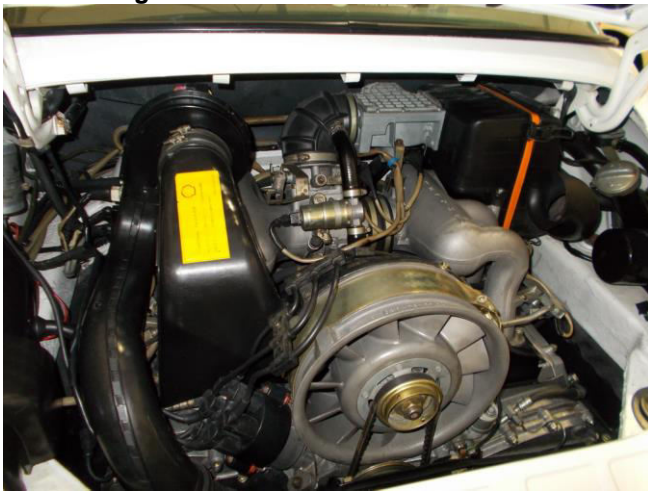
**loose wire on oil sender**

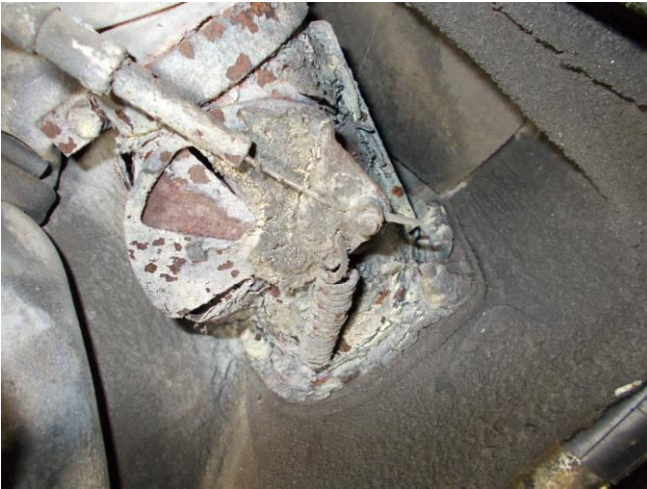
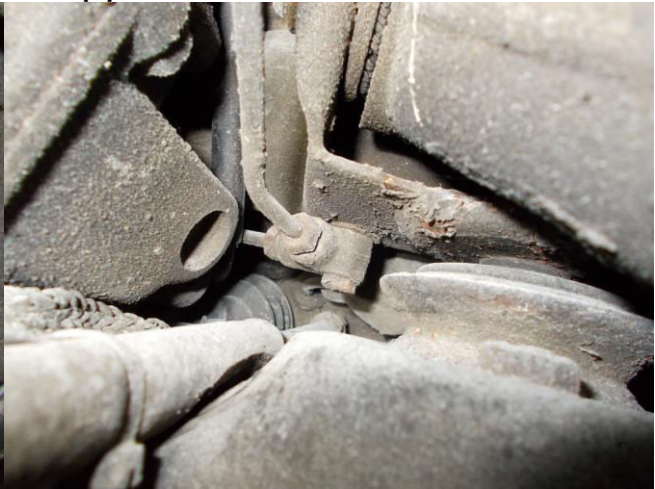
**Heater valves free**

**brake pipes solid**

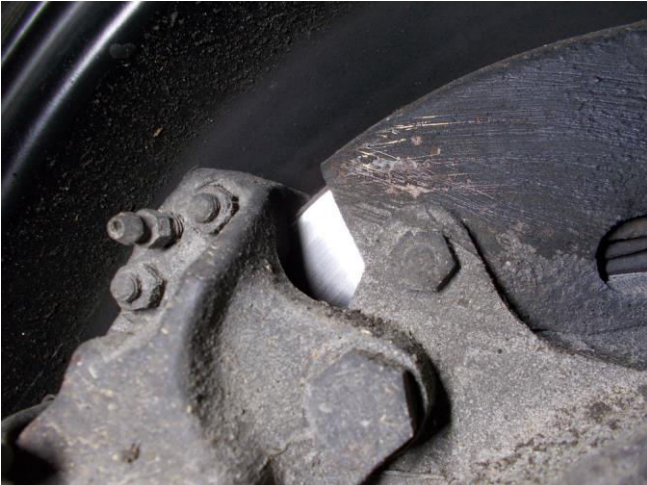
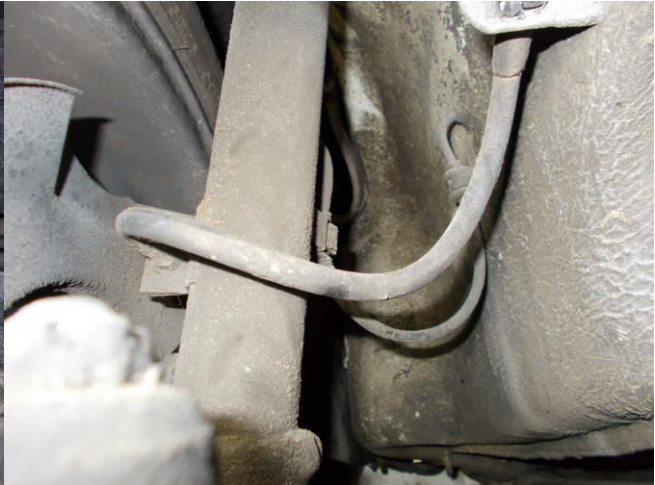
**Rear brakes ok**

**brake hoses old but ok**

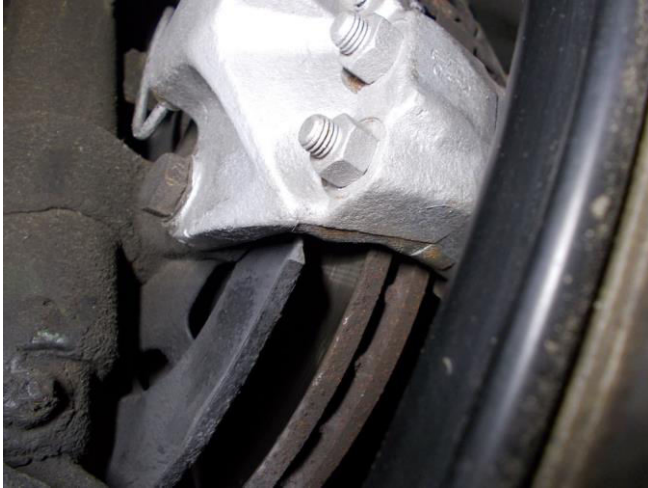
**Front brakes ok**

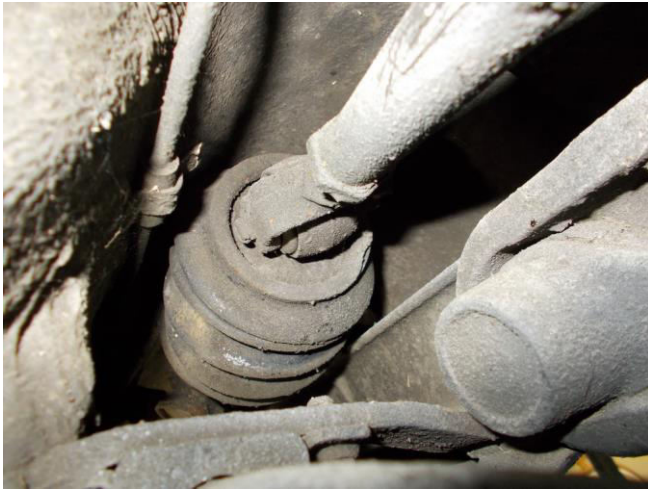
**Rack boots intact**

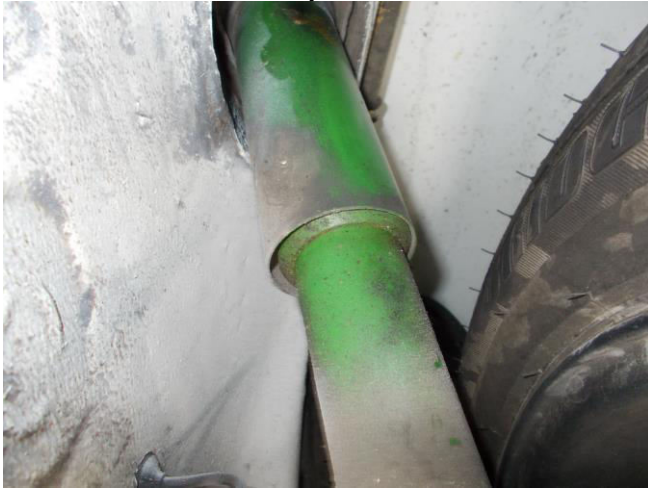
**No leaks from front dampers**

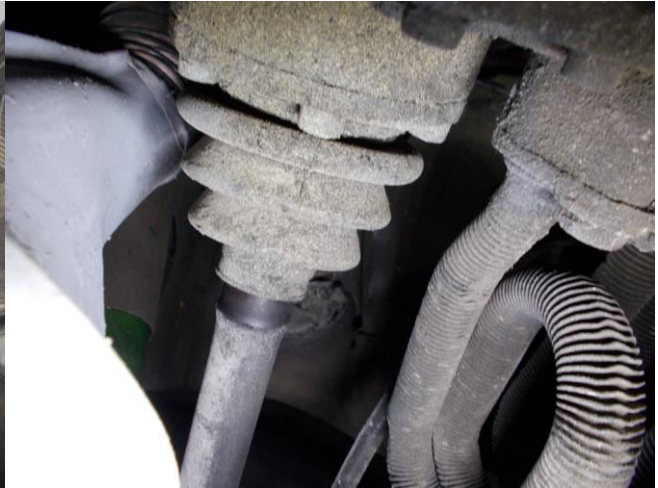
**CV boots intact**

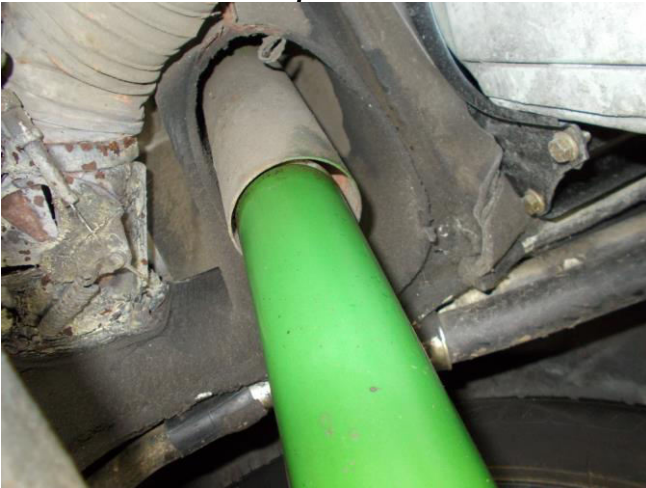
**No leaks from rear dampers**

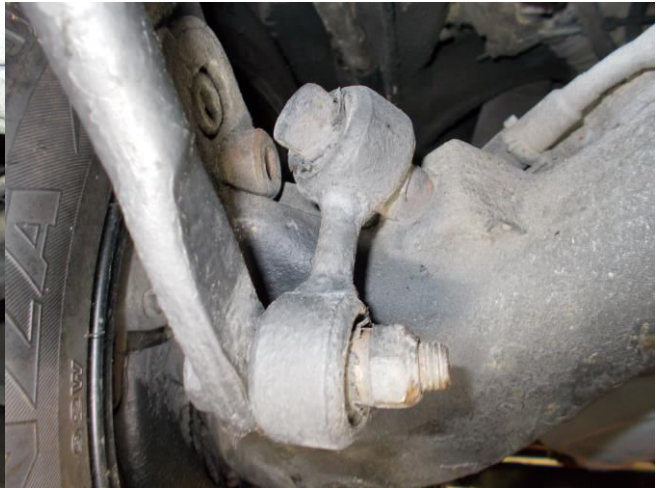
**rear roll bar links ok**

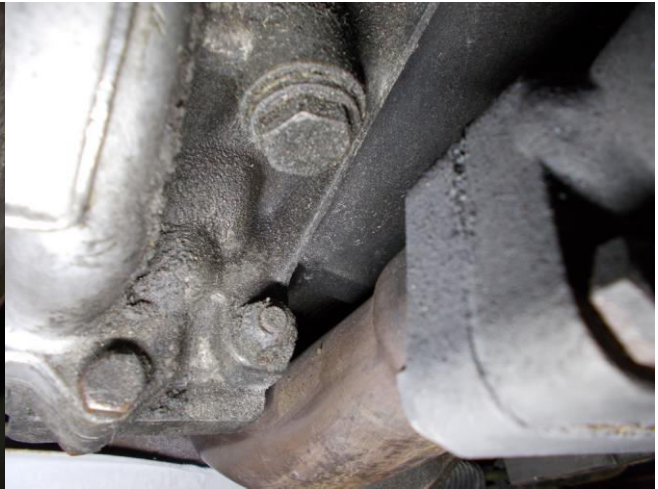
**or RMS**

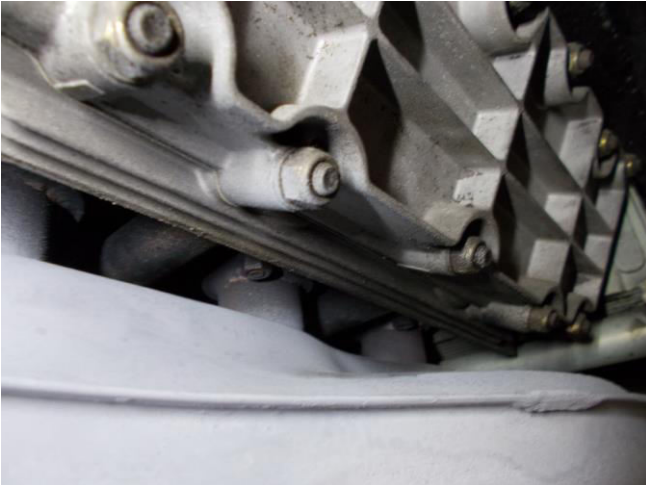
**No leaks from cam covers**

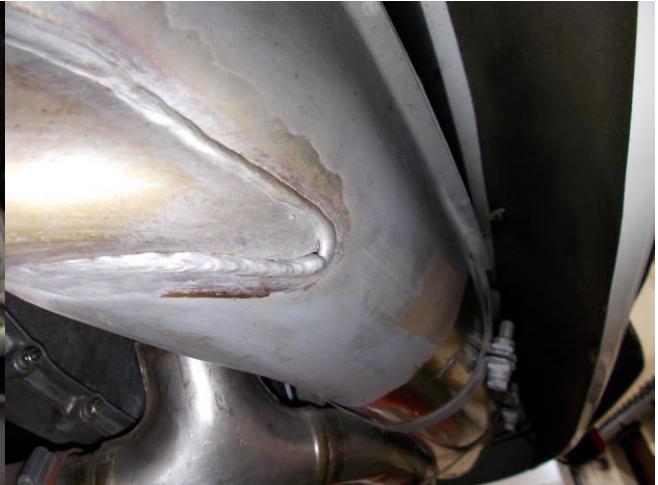
**excellent exhaust**

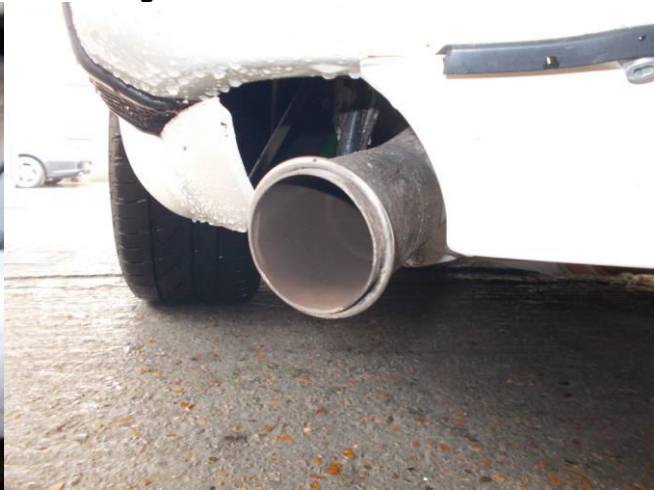
no smoking from exhaust
